Acute Epileptic Electricity Supply in Isoko North LGA of Delta State, Its Causes and Remediation

*¹Obukoeroro John and ²Uguru, H. E.

¹Electrical/Electronic Department, Delta State Polytechnic Otefe-Oghara, Nigeria.

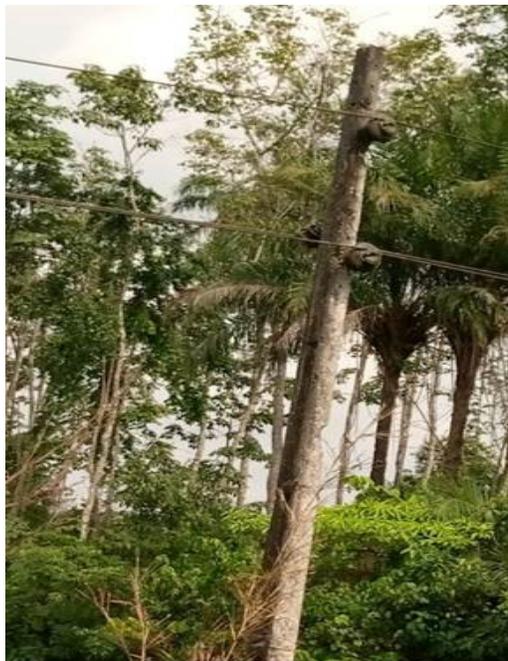
The field survey revealed that the 33 KVA transmission line transmitting electricity from Ughelli Power station to Isoko North LGA, contained a lot of faulty points. These faults ranged from sagging transmission cables to missing insulators. Case of the pin insulators attached directly to the utility poles, due to lack of cross arms (Figure 2), were common occurrence along the transmission line. It was observed during the field survey that some of the utility poles tips had broken; thence the cross arms were hanging at the edges of the pole (Figure 3). Attaching the insulators directly to the utility pole is very dangerous, as it can lead to voltage leakage or electrocution, during downpour, still the earth had been

Figure 2: Insulator attached directly to the utility pole at Oleh Community. **Figure 3:** Hanging cross arm at Emede Community.

distorted. Also the tendency of the cables been bridged by reptiles, falling trees, etc. is higher, as the distance between the cables is smaller than the required NIS standard. It was observed at man points, mostly inside most of the communities that the right of way of 11 m approved by the NIS as not adhered to. According to NIS, transmission line construction in Nigeria power sector must meet the IEC 60826 provisions. Therefore, it must be capable of withstanding expected electrical and climatic loads while maintaining design consistency between strengths of line components (Nigerian Electricity Regulatory Commission [NERC], 2014).

(i) Overhauling of the entire 33 KVA and distribution lines. Some sections distribution lines are obsolete when compared to the NIS recommendations. The overhauling should be done in accordance to the NERC and NIS recommendations. This will help to minimize the rate at which electromechanical faults occurred along the lines. Hence, power outages will be minimized, since a lot of the power failures experienced in the area are due to electromechanical faults.

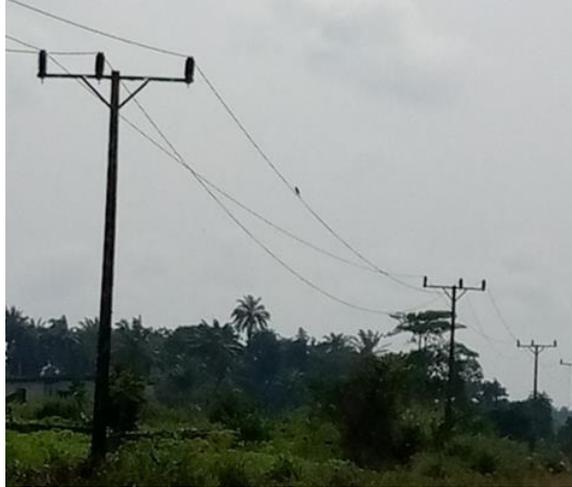
Additionally, extremely sagging of the transmission line was notice at various points (Figure 4). The sagging was very obvious in the forest regions, where the transmission line passes through. These conditions are against the standard practice of electrical installation and safety standards. Although, the tension in the cable should not be too high, as the cable can snap under high voltage; but excessive sagging of the cable can lead to electrical problems. According to Oluwajobi *et al.* (2012), excessive sagging of transmission cable is liable for causing power failure. High voltage sagging transmission cable can touches trees, during windy condition; hence, creating electrical sparks which usually leads to power failure. Additionally, Liquidators (2020) stated that extreme sagging of transmission cable is hazardous; it falls below the recommended height, as the cable will come with contact with trees, buildings and other structures beneath it; therefore causing electrical fire and electrocution.

Figure 4: Sagging transmission cables Between Oleh and Ozoro community.

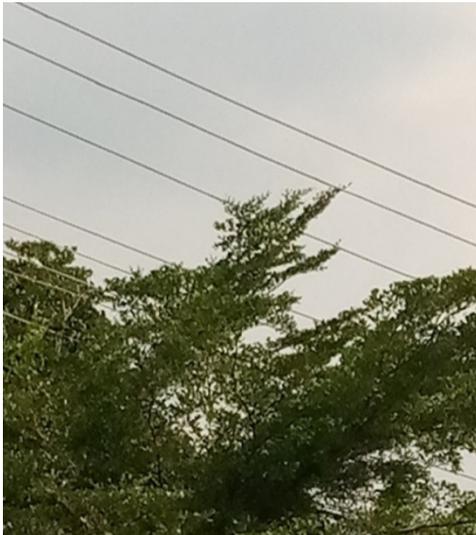
During the field work, it was notice that some of the primary and secondary distribution lines were not hitch free. Slanting utility poles and cables overgrown with trees were observed in the field (Figures 5 and 6). As seen in (Figure 5), the secondary distribution lines were covered with trees branches. This is unsafe for both the residents of the area, and the power transmission system. The tendency of the cables been bridged during light breeze or rain is higher, since wet materials (wood) are good conductor of electricity. These poor states of the distribution lines can results in high energy losses, damping oscillations and instability in the 33 KVA transmission line (Onohaebi and Omorogiuwa, 2014). According to Onohaebi and Omorogiuwa 2014), high demand for electricity above the production capacity, couple with poor transmission and distribution facilities are the major causes of consistent power failure in Nigeria (Omorogiuwa and Ike, 2014).

Figure 5: Secondary distribution line overgrown with trees.

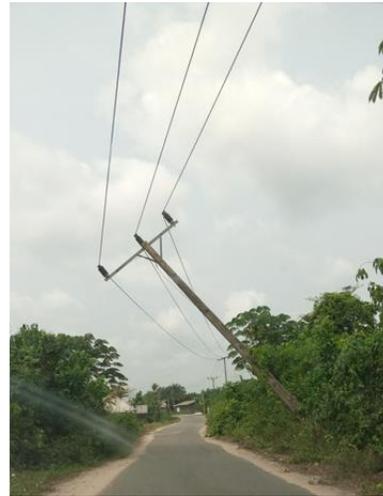
Figure 6: A slanting utility pole at Owhe community

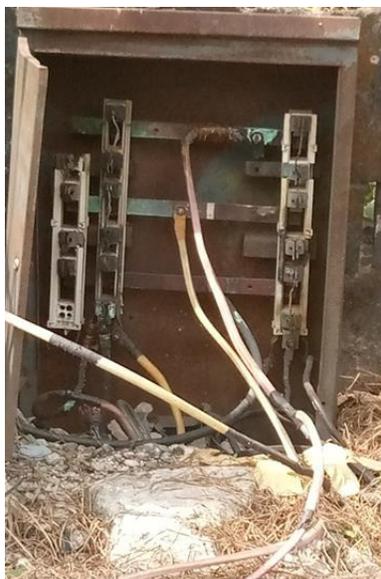
The field survey revealed that most of the power transformers were in bad conditions, and unable to operate at the rated capacity. Incidence of built amour cables and feeder pillars were high in most of the transformers visited (Figure 7). Standard NIS rating fuses were missing in almost all the feeder pillar visited, as the feeder pillars were fused with copper wires of unknown

rating. The implication of this unethical act is that, any fault in the secondary (415 V) distribution line can bypass the feeder pillar (if a higher rating fuse wire is used), and affect either the transformer or the primary (11 KVA) distribution line. This can cause major power outage that can take weeks or months to rectify. Information obtained from the BEDC staff revealed that in cases they fused the feeder pillar, with very low rating wire, to safeguard the transformer and transmission line for overloading or other electrical faults. But this act can lead to consistent electric power tripping off, which will affect the consumers the 415 V transmission lines are servicing. According to NERC and NIS recommendations, Transformers fuses must be installed

Figure 7: A transformer feeder pillar.

in accordance with manufacturer's specifications (NERC, 2014).
